RESIDENTIAL REPORT

Harborside Terrace Owners Association, Inc.
4200 Belair Ln.
Naples, Florida 34103

Phase One Milestone Inspection

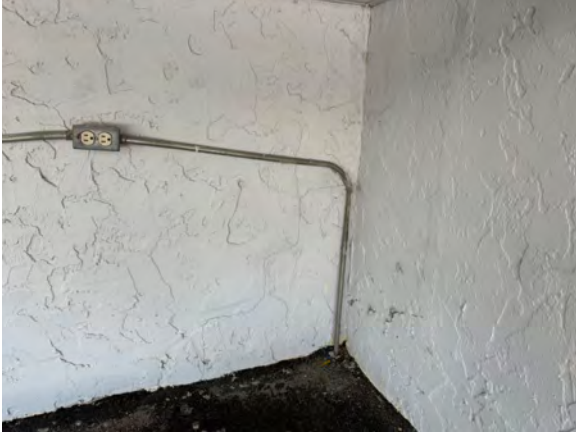
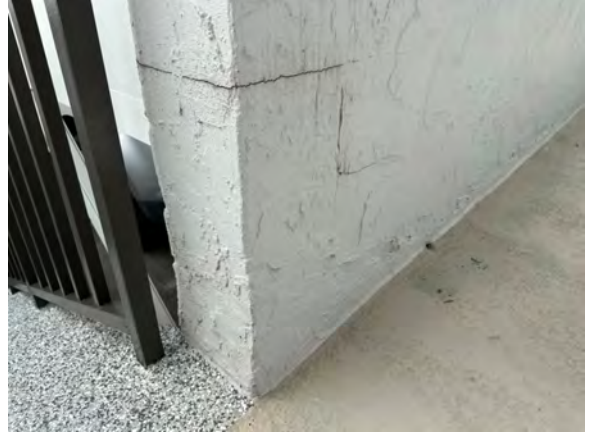
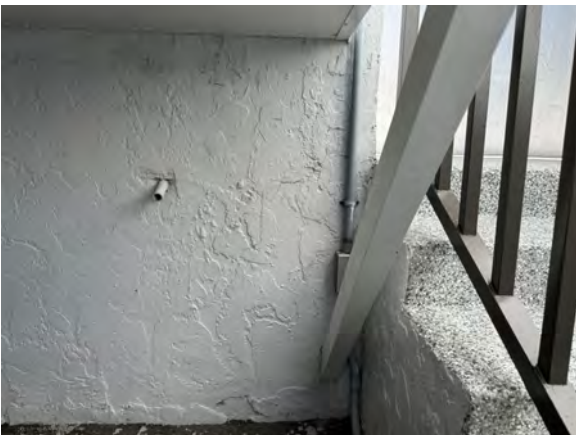
1.P.1

1. Cracking in CMU grout joints within the covered car ports
2. Cracking in CMU grout joints in the retaining walls in front of units 101 & 116
3. Paint peeling and cracking
4. Cracking on the stucco finish throughout the entire building
5. Cracking on the decking finish throughout the back side of the building
6. Hollow/loose finish on the decking in front of, and in between units 103 & 104 on the back of the building
7. Light bulb is out in the South electrical room
8. Rusted condensate piping exiting the front of the building in multiple locations
