STRUCTURAL INTEGRITY RESERVE STUDY

Harborside Terrace

4200 Belair Lane

Project Number 2324043

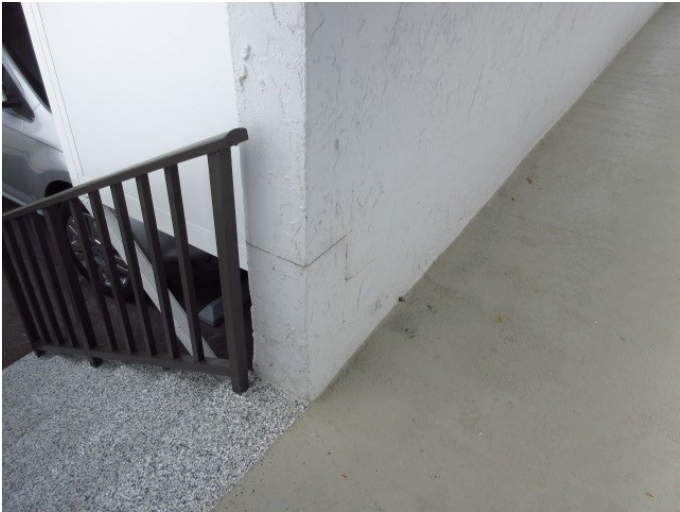
PHOTO 22

VIEW OF CMU STEP-CRACKING

Item No.	Item Description	Quantity	Unit	Cost	Totals	Comments
2	Exterior façade	1	Budget	\$10,000	\$10,000	Exterior stucco & concrete cracks, and expansion joints repair
					Subtotal	
				Total Immediate Repairs	\$10,000	
				Cost Per Unit	\$185.19

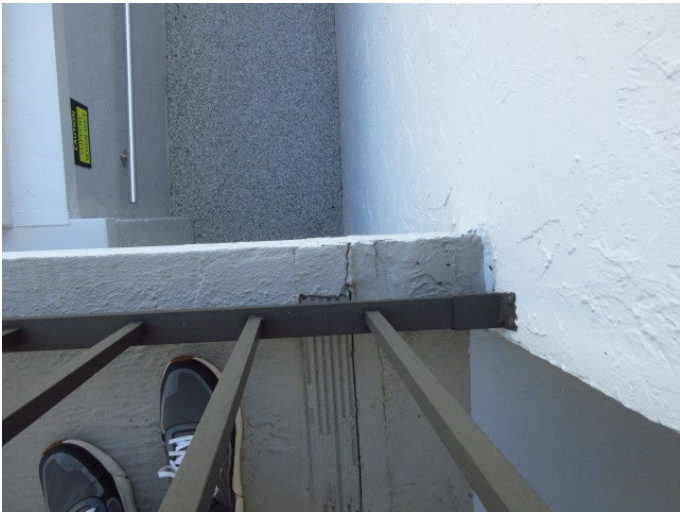
PHOTO 23

VIEW OF FAILING EXPANSION JOINT

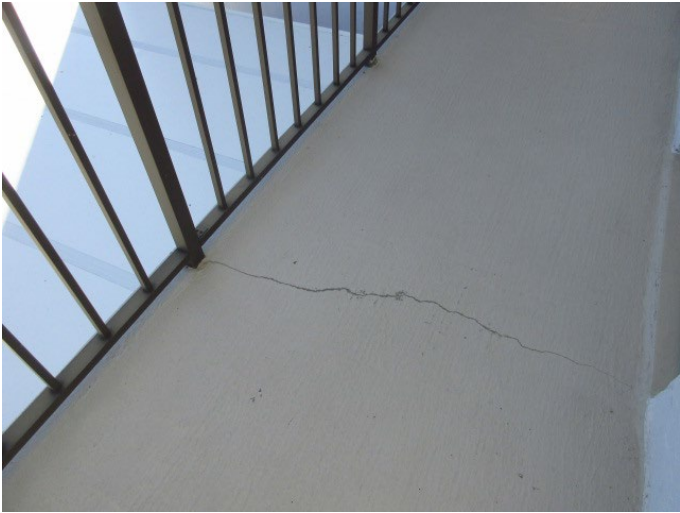
PHOTO 24

VIEW OF CRACK AT ELEVATED WALKWAY
