Uniform Mitigation Verification Inspection Form

Inspection Date: 03-22-2023		
Owner Information		
Owner Name: Harborside Terrace Condominium Association		Contact Person: Board Member or Owner
Address: 4200 Belair Lane		Home Phone:
City: Naples, FL	Zip: 34103	Work Phone:
County: Collier		Cell Phone:
Insurance Company:		Policy #:
Year of Home: 1975	# of Stories: 3	Email:

Harborside Terrace Condominium Association
4200 Belair Lane, Naples, FL 34103
03-22-2023

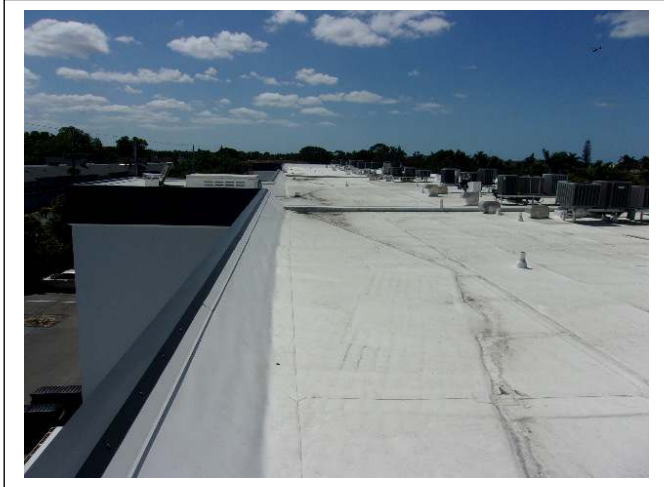
ROOF COVERING SYSTEM – The roof covering system is fully functional with no deficiencies observed. The mechanical devices appear to be properly secured.

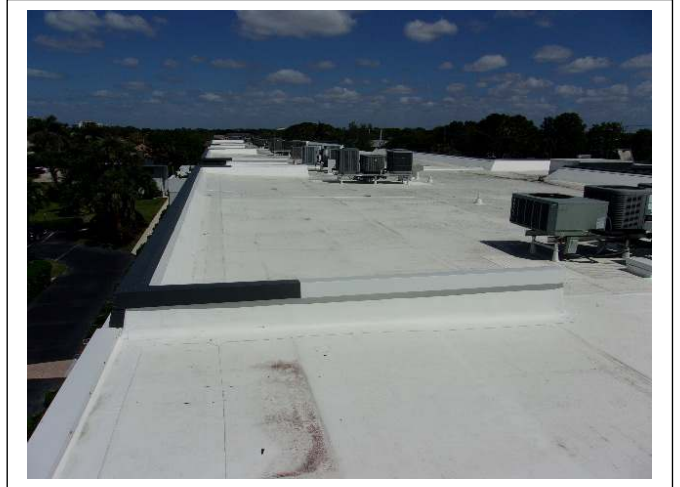
ROOF COVERING SYSTEM – The roof covering system is fully functional with no deficiencies observed. The mechanical devices appear to be properly secured.

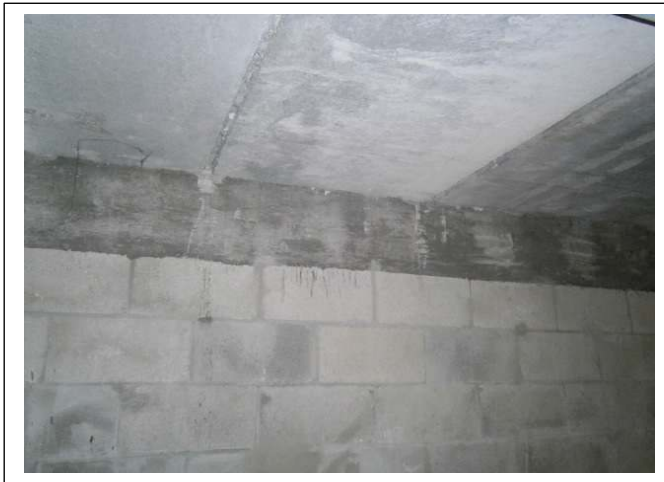
REINFORCED CONCRETE ROOF DECK & REINFORCED CONCRETE WALLS

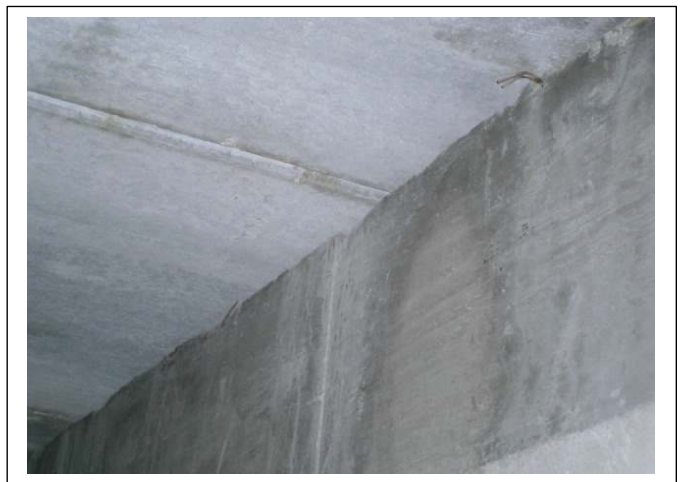
REINFORCED CONCRETE ROOF DECK & REINFORCED CONCRETE WALLS

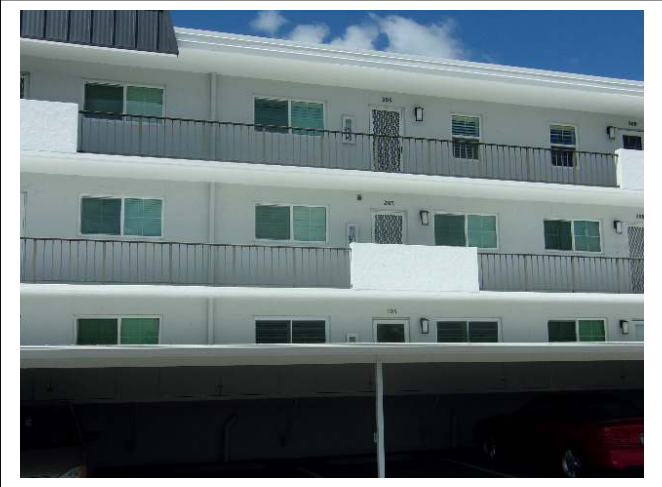
OPENING PROTECTION – Although some unit owners have installed wind-borne debris protection devices, other have not, leaving some of the hinged entry doors & sliding doors) unprotected. All windows are impact rated.

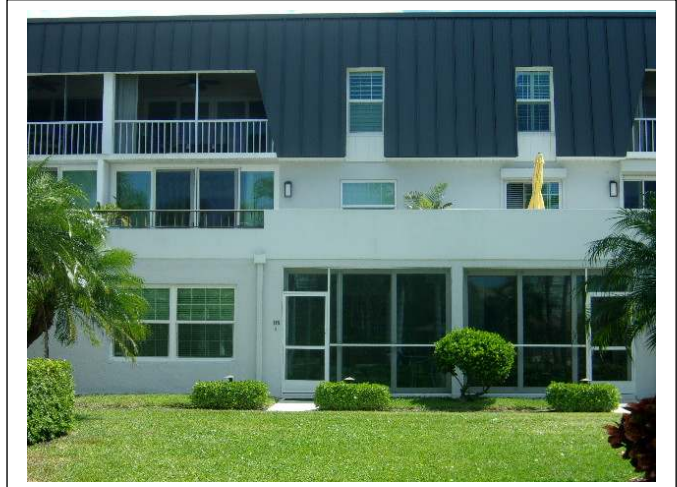
OPENING PROTECTION – Although some unit owners have installed wind-borne debris protection devices, other have not, leaving some of the hinged entry doors & sliding doors) unprotected. All windows are impact rated.
